**Flood Control Project Maintenance
Levee Inspections**

Maintenance Issue Types Only, Levee Inspection Report By Mile - Spring 2020

Sutter Maintenance Yard Maintenance Area 0003

Waterway	Bank	Unit Miles	Inspection Start/End	Inspector
Unit No. 01 Feather River	Right	5.11	03/18/2020 03/18/2020	Sterling York

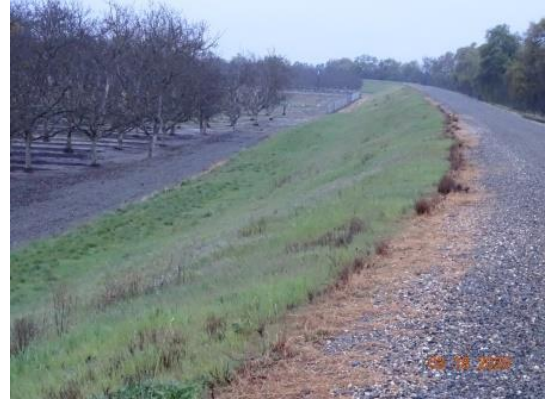
Photo 1 of 1 : SP_2020_MA0003_195_12_20200327_00024.jpg

LM Start	0.01	Rating **	A	Issue No.	12
LM End	3.99	Issue Type +	Ma	Location *	LS
Category	Earthen Levee			GPS Latitude/Longitude	
				Start	End
Item	Vegetation			38.898005 °	38.935226 °
				-121.617932 °	-121.589146 °
DWR ID	DWR_MA0003_01_s_2020_12				
Comment Code					
V1 : Control annual grass and weeds on the levee slopes and easements.					
Inspector Comment					
The annual vegetation is well maintained, Spring 2020.

View looking upstream landside at the well maintained annual vegetation, Spring 2020.

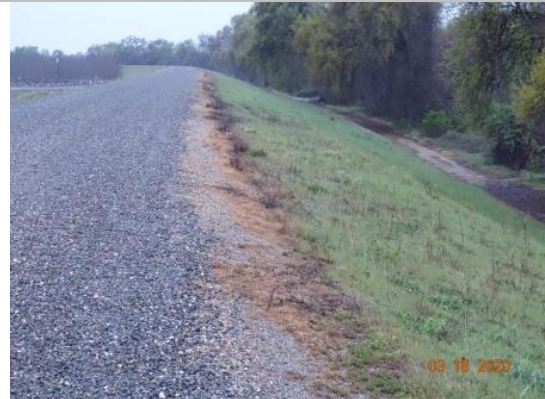
Photo 1 of 1 : SP_2020_MA0003_195_17_20200327_00025.jpg

View looking upstream waterside at the well maintained annual vegetation, Spring 2020.

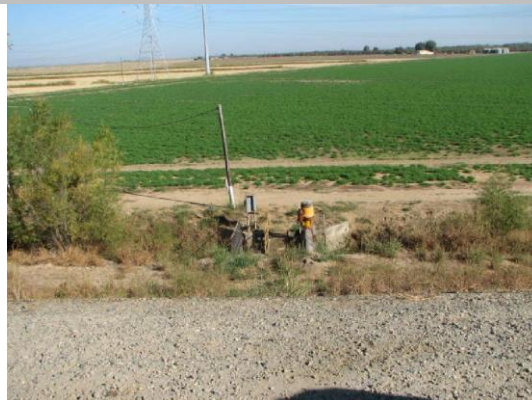
Photo 1 of 3 : UCIP_SP_2020_54171_64649.jpg

UCIP Comments: 05/01/2019 Same as last inspection, record remains Urgent due to the potential of levee integrity issues on the LS. Dense vegetation on both the WS and LS limits the inspection to determine if sink hole or erosion behind headwall on LS has progressed. No permit has been identified for this structure. Structure has been abandoned.

(O. Magana - DWR UCIP)10/04/2018 Sink hole observed between the dual 18-inch pipes located on the LS near the concrete headwall.

Erosion was also observed behind the concrete headwall located on the LS. Inlet of dual 18-inch pipes was still covered by filled sandbags.

Concrete headwall with walkway and slide gates at LS toe.

Crossing remains Urgent due to the sink hole and erosion visible on the LS. These crossings were recommended for replacement under the SBFCA project; however, no work has been done to date. Recommend monitoring site and coordinating with SBFCA to determine the status of the project. (O. Magana - DWR UCIP)

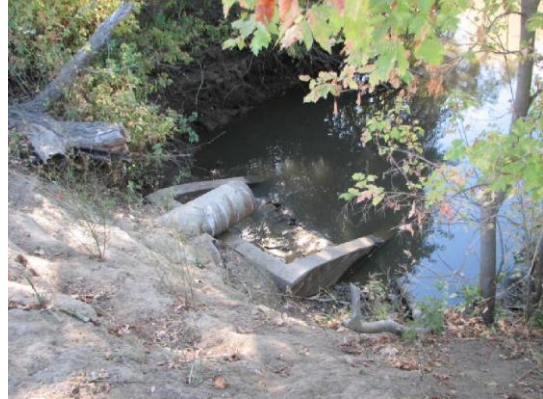
Photo 2 of 3 : UCIP_SP_2020_54171_64648.jpg

Concrete U shaped headwall on WS toe filled in with Sandbags. 16-inch pipe shown over top of headwall.

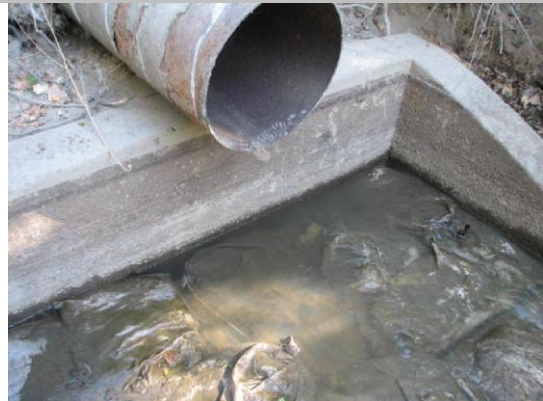
Photo 3 of 3 : UCIP_SP_2020_54171_64647.jpg

Concrete U shaped headwall filled in with sandbags on WS toe. Flap gates appear to be missing and water readily flows through the sandbags from LS.

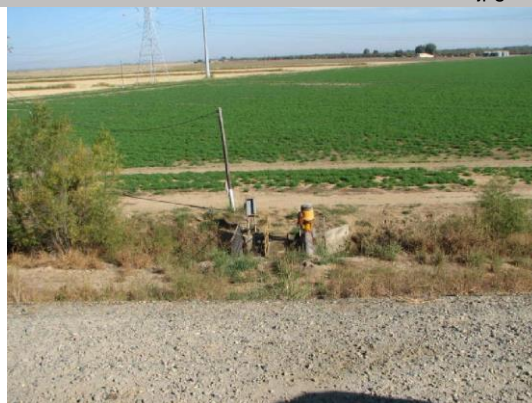
Photo 1 of 3 : UCIP_SP_2020_56067_64662.jpg

DS_ID:17136
FS_ID:56067
EP_NO: N/A
Repair Type: Urgent
Crossing Status: Found
UCIP Comments: 05/01/2019 Same as last inspection, record remains Urgent due to the potential of levee integrity issues on the LS. Dense vegetation on both the WS and LS limits the inspection to determine if sink hole or erosion behind headwall on LS has progressed. No permit has been identified for this structure. Structure has been abandoned. (O. Magana - DWR UCIP)10/04/2018 Sink hole observed between the dual 18-inch pipes located on the LS near the concrete headwall. Erosion was also observed behind the concrete headwall located on the LS. Inlet of dual 18-inch pipes was still covered by filled sandbags. Crossing remains Urgent due to the sink hole and erosion visible on the LS. These crossings were recommended for replacement under the SBFCA project; however, no work has been done to date. Recommend monitoring site and coordinating with SBFCA to determine the status of the project. (O. Magana - DWR UCIP)

Concrete headwall, slidegates, and metal walkway on LS toe.

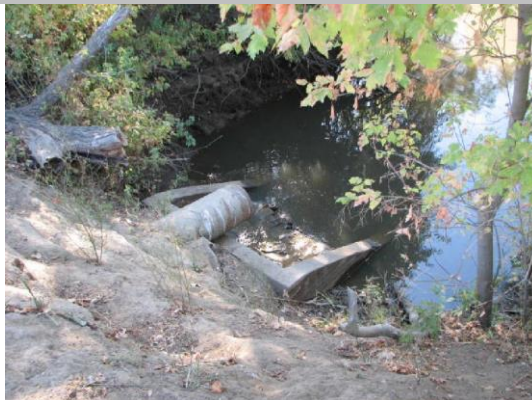
Photo 2 of 3 : UCIP_SP_2020_56067_64661.jpg

Concrete U shaped headwall on WS toe filled with sandbags.

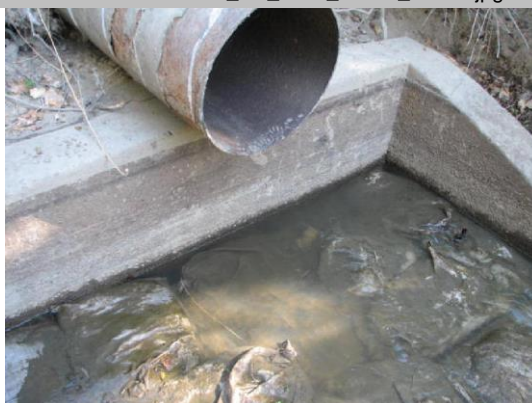
Photo 3 of 3 : UCIP_SP_2020_56067_64660.jpg

Flap gates appear to be missing from U shaped headwall. Sandbags fill headwall but water flows heavily from LS.

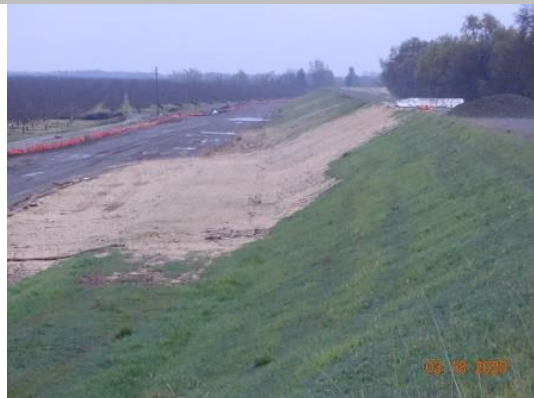
Photo 1 of 2 : SP_2020_MA0003_195_15_20200327_00026.jpg

LM Start	3.99	Rating **	A/W	Issue No.	15
LM End	5.10	Issue Type +	Ma	Location *	CR
Category	Earthen Levee			GPS Latitude/Longitude	
				Start	End
Item	Crown Surface / Depressions / Rutting			38.935226 °	38.950762 °
				-121.589146 °	-121.585810 °
DWR ID	DWR_MA0003_01_f_2019_15				
Comment Code					
C1 : Add appropriate material and re-grade the levee to bring the crown above the design elevation.					
Inspector Comment					
Still under USACE construction on this portion of levee, Spring 2020.

View looking upstream at the portion of levee that is still under construction, Spring 2020.

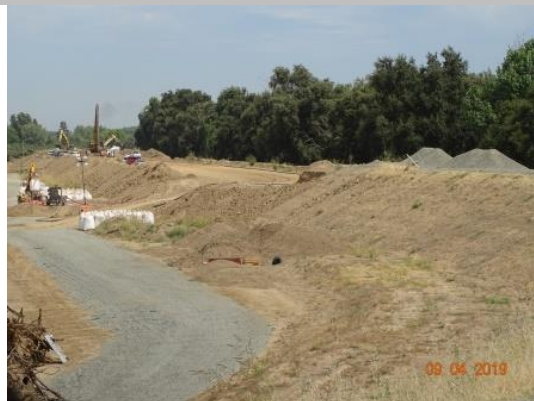
Photo 2 of 2 : SP_2020_MA0003_195_15_20200227_00003.jpg

View looking upstream at the portion of levee that is under construction, Fall 2019.
